Case study: implant dentistry 'upside down'

Stephen E B Jones, Specialist in restorative dentistry and Ben Page, dental technician describe a case study where implants are placed directly to fit existing fixed restorations

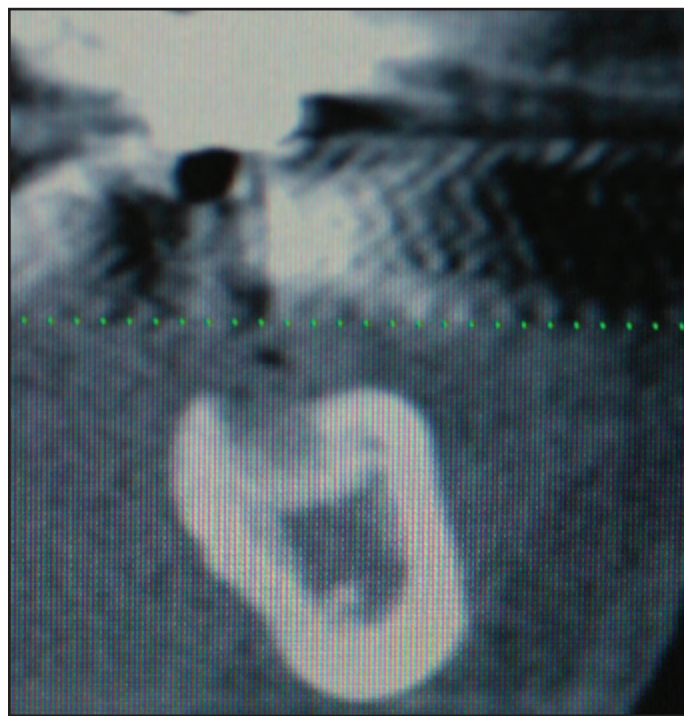
Figure 3: CT scans of sites

A computerised tomography (CT) scan was taken. This showed the presence of intact lingual and facial bony plates of good dimensions at both infected sites and the inferior dental nerve canals situated immediately beneath.

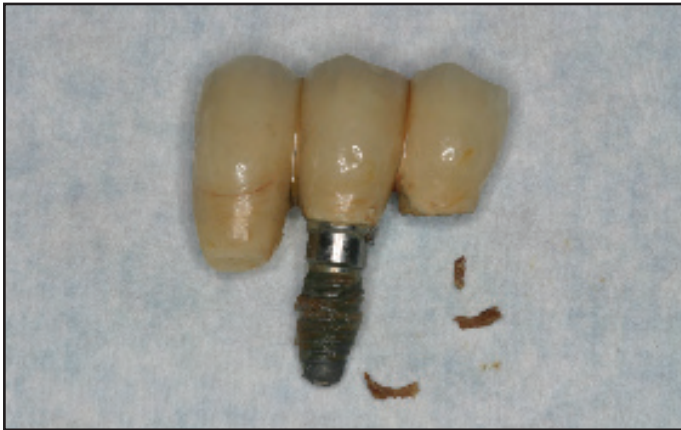
Figure 4: Bridge with cement fragments

infected implant as well. In Figure 1 cement can be seen at the top of the thread on the implant 'in situ'. In Figure 4 the cement fragments that were attached can be seen. The reason for the periimplantitis was because the bridge margins at the more distal implants had both been cemented subgingivally into a tight tissue cuff only previously occluded by relatively narrow healing abutments. In seating the bridges the cement had been extruded subgingivally, under pressure, and this cement had traversed the polished titanium collar to adhere to the roughened implant surface. This was the subject of an elegant laboratory study over 10 years ago (Agar et al, 1997) and is a well known hazard of cement-retained prosthodontic work on implants, especially in the aesthetic zone where it is often desirable to place crown or bridge margins subgingivally. This superfluous cement ridge acts as a ligature, of the type that has been seen to produce a rapid periimplantitis (Zitzmann et al, 2004) in animal experiments. Periimplantitis represents an inflammatory condition that is usually only associated with the presence of a submarginal biofilm and with advanced breakdown of soft and mineralised tissues surrounding dental implants. These rapidly progressive periodontal lesions have been observed many times anecdotally in the dental literature and many of these are probably associated with

thoroughly immediately after removing the implant and bridge but it was decided not to reopen the healing socket on the lower left for curettage. Both lower bridges, together with attached implants, were returned to the dental laboratory and heated slowly to break the cement seal between the exfoliated implant abutments and the bridges. The two implants and cast-on gold abutments were then returned to Nobel Biocare UK for replacement under their 10-year warranty agreement.

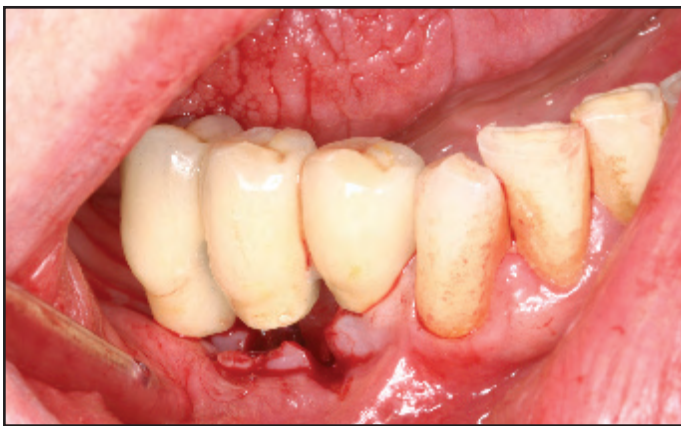
Figure 6: Bridge over guide pin

4.3mm Replace Select RP, TiUnite surfaces) implants were placed under infiltration local anaesthetic (Articaine 4% with 1:100000 adrenaline). Both bridges located well on the anterior undamaged abutments and so were able to be used as accurate positioning guides for the new implants. This was accomplished by establishing the correct position under the bridge with a 2mm twist-drill then verifying this using guide pins before completing the drilling sequence. The CT scan establishes the buccolingual dimensions with a degree of accuracy that allows only minimal flap

elevation to be undertaken. The procedure on the right side is shown in Figures 5-7. The surgical procedure was exactly the same on the left side.

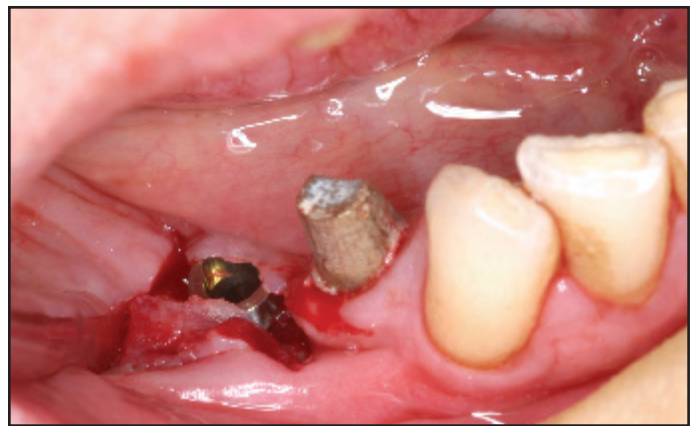
Figure 7: Implant placed

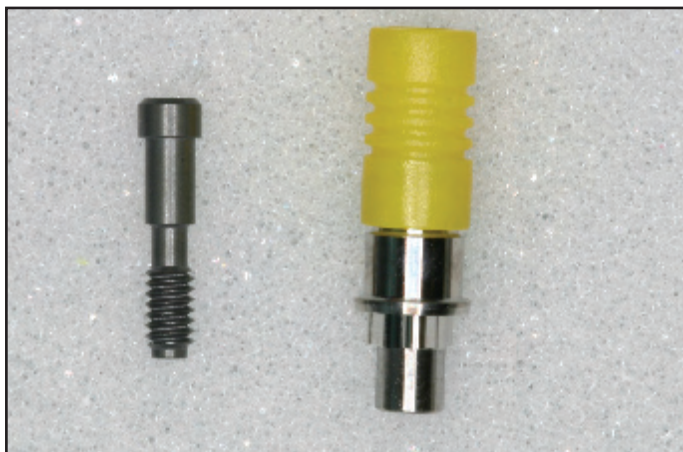
Figure 10: Cast-on gold abutment as supplied

made of the lower arch in polyvinylsiloxane impression material (Flexitime, Heraeus Kulzer Ltd). A model was produced using 4.3mm implant replicas (ReplaceSelect, Nobel Biocare UK Ltd). Two new engaging cast-on GolAdapt abutments (Nobel Biocare UK Ltd) were cut down as required to engage the old bilateral bridgework using a rigid bite registration

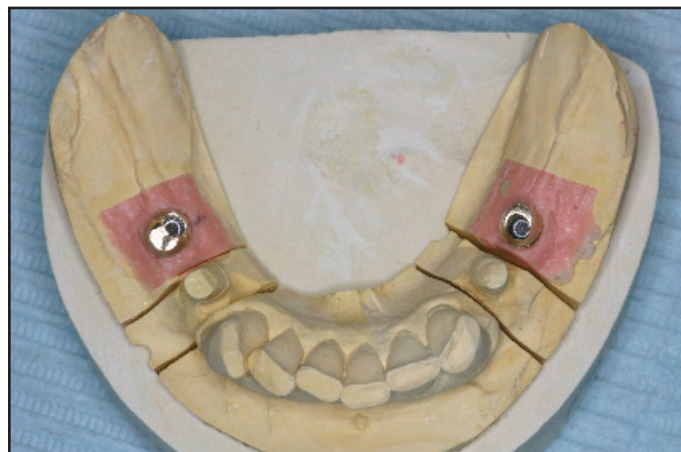
Figure 11: New cast gold abutments on model (GoldAdapt, Nobel Biocare UK Ltd)

putty indices. A small amount of Vaseline (Elida Faberge Ltd) was used as a separator inside the bridges and the abutment shapes were formed with pattern resin (Duralay, GC Ltd) incrementally applied to the GoldAdapt (Nobel Biocare UK Ltd) abutments. The abutment screw access holes inevitably became occluded by pattern resin and so the set resin had to be cut away to gain access to each screw head. Each abutment was then invested using Moldavest Exact (Heraeus Kulzer Ltd) and placed in the furnace at room temperature, then held at 250 degrees centigrade for one hour to burn out the pattern resin. Then the temperature was raised to the final casting temperature of 700 degrees centigrade and both abutments were cast using 3 STAR alloy (Metalordental Ltd) and were left to cool on the bench. A small layer of red lipstick was painted inside the fit surface of each bridge to show high spots on each casting. These were adjusted and after finishing and sandblasting the work was returned to the surgeon for fitting.

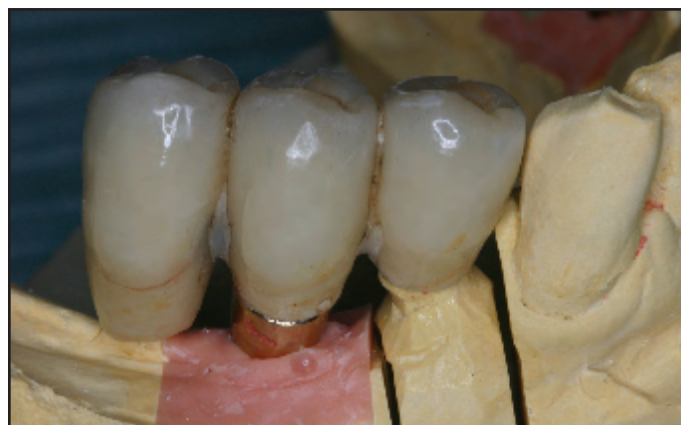
Figure 13: Refitted bridge

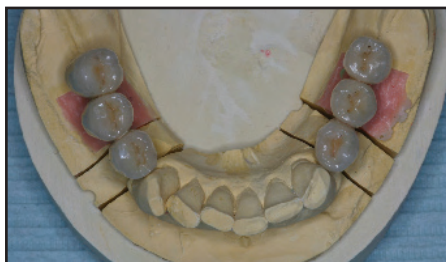
Figure 14: Bilateral bridges on new abutments returned for fitting

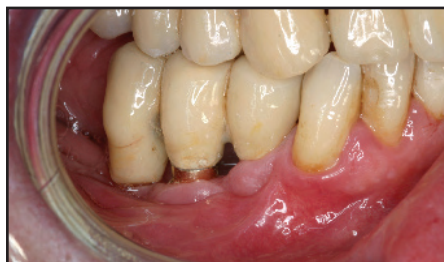
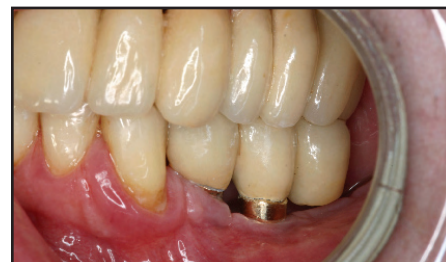
Figures 15 and 16: Right and left bridges definitively recemented

There was some minor occlusal adjustment to the occlusal surface of the right bridge, but none to the left bridge. After tightening the abutment screws to 35Ncm the screwheads were covered with a soft wax plug. Both bridges were cemented with RelyX Unicem (3M/ESPE Ltd) and the occlusion rechecked. Because of the inevitable loss of alveolar ridge hard and soft tissue after the loss of the implants the new bridge margins were inevitably coronal to the gingival margins. This was not a problem aesthetically and safeguarded against leaving any excess cement second time around. A high level of oral hygiene can be easily achieved because of the necessarily wide residual embrasure spaces present.
